Western Gear Report No 635-214

HIGH ENERGY RATE FORGING DEVELOPMENT

Fifth Interim Technical Progress Report

10 October 1962 - 10 May 1963

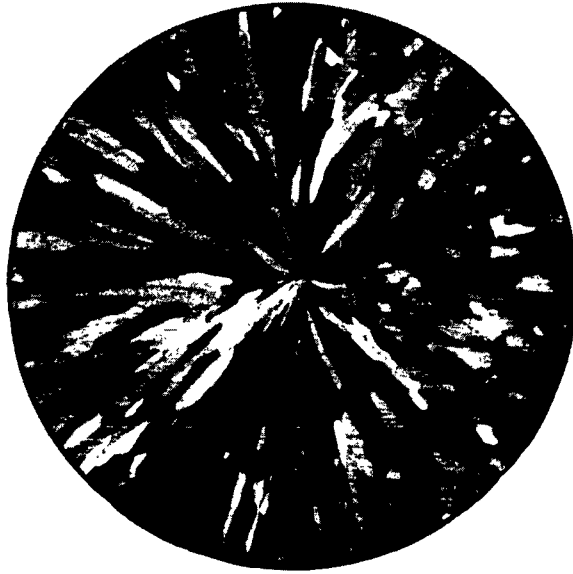
Figure 1 - Macroetch arc-melted tungsten billet showing equi-axed structure at one end and columnar grains on the other end. Approx. 1.5 X mag.

Macro-examination of the arc melted tungsten and TZM billets disclosed a columnar grain structure at one end of the billet and the equi-axed grains at the other end (Figure 1). Most of the billets had been forged before this fact was discovered. Upon checking with the supplier, it was learned that seven tungsten and seven TZM molybdenum alloy billets could have been in this condition. All of the TZM alloy billets with the columnar structure and all but one of the tungsten billets were forged.

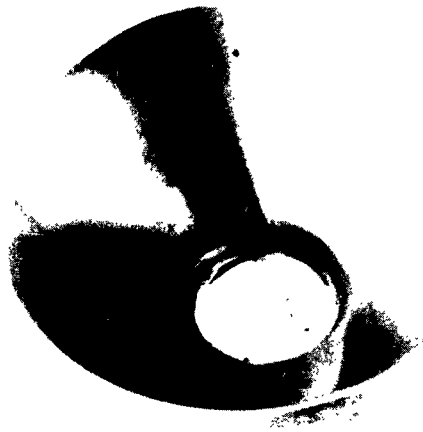
Figure 12

**HIGH - ENERGY - RATE - FORGED
TZM MOLYBDENUM
ROCKET NOZZLE INSERT**

During this reporting period work continued on developing forging techniques to forge these materials into a rocket nozzle insert as shown in Figure 12. All billets were heated to forging temperature in a Lindberg recirculating gas-fired furnace. Heating was accomplished without the use of a protective atmosphere since it was previously established that metal losses due to oxidation were relatively low (under 3%).

In the previous reporting period, the program had met with a large degree of success. Sound forgings having a wall thickness of approximately 0.090 inch were produced from both arc melted and pressed and sintered billets (Figures 12, 13 and 14). These forgings were produced in the following manner.

Blocking was performed in one blow using a fire pressure of 900 psi, 6-3/8 inch stroke, and 2200°F forging temperature. The blocked forgings (Figure 15) were then cooled in lime to room temperature. Next, the forgings were heated to 2050°F and struck two to three blows in the finisher dies with a fire pressure of 400 psi. Reheating was performed between each blow. This procedure resulted in sound forgings approximately 80% of the time (Figures 12, 13 and 14).

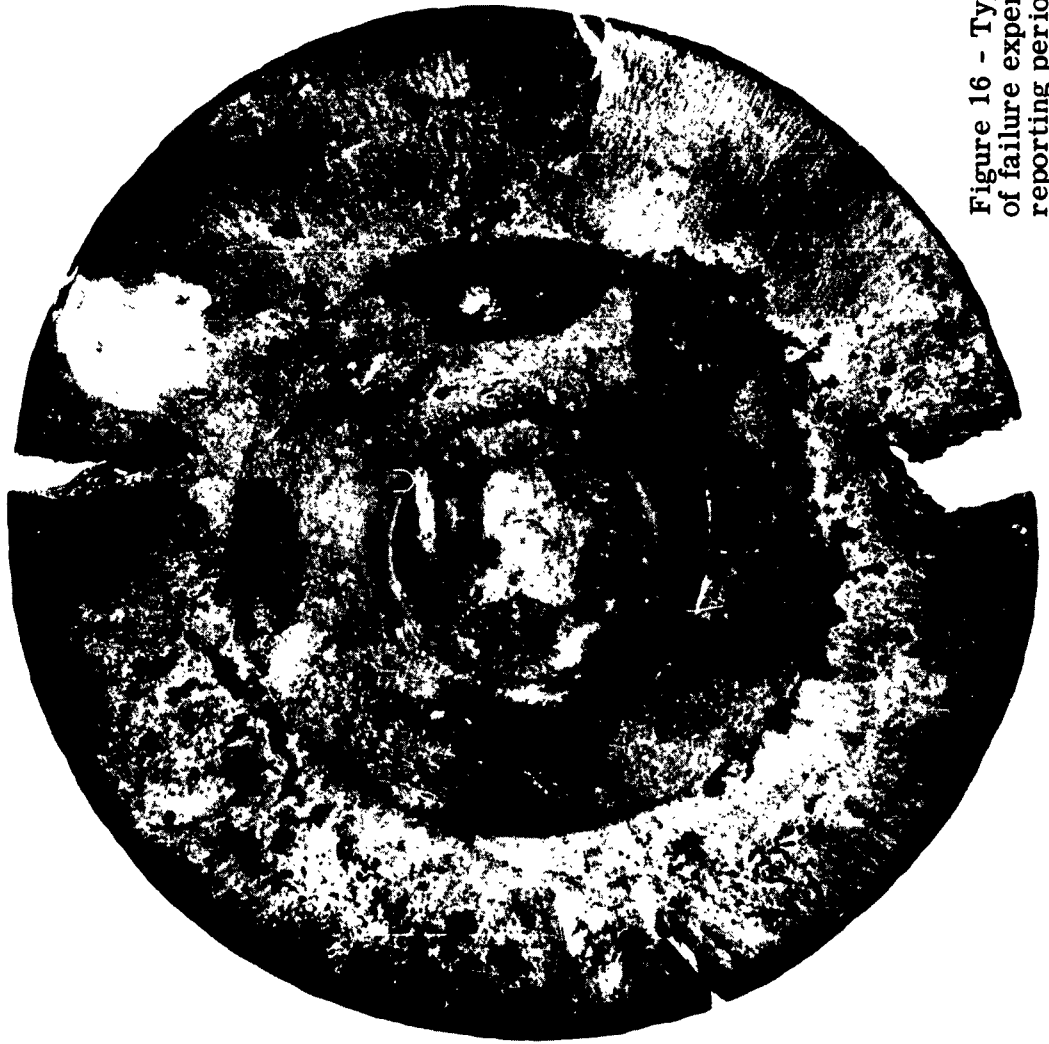
Figure 16 - Typical example of the type of failure experienced during the current reporting period. Material is arc melted TBM molybdenum alloy. Cracking was along grain boundaries.

The finisher die was placed in the machine and one of the pressed and sintered billets was struck at 1950°F with a fire pressure of 500 psi. It exhibited severe radial cracking through the flash zone and into the body to the forging. Next, the forging temperature was increased to 2050°F keeping the fire pressure at 500 psi. This forging cracked in the same manner as the previous one. Maintaining the 2050°F forging temperature, the next three forgings were struck blows at 400 psi. One of the three cracked radially through the flash (Figures 16, 17 and 18).

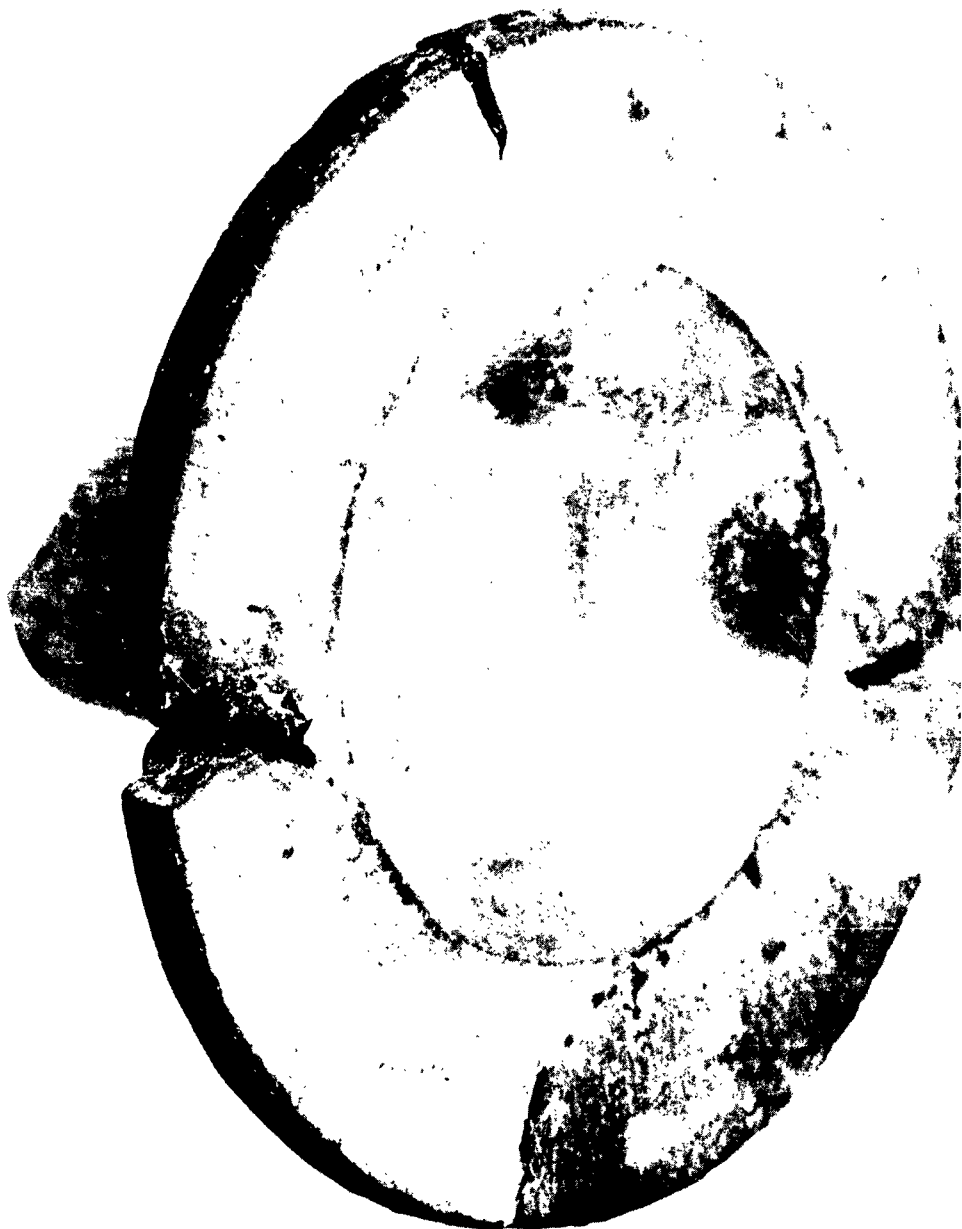
Figure 17 - Typical example of the type of failure experienced during the current reporting period. Material is arc melted TZM molybdenum alloy. Cracking was along grain boundaries.

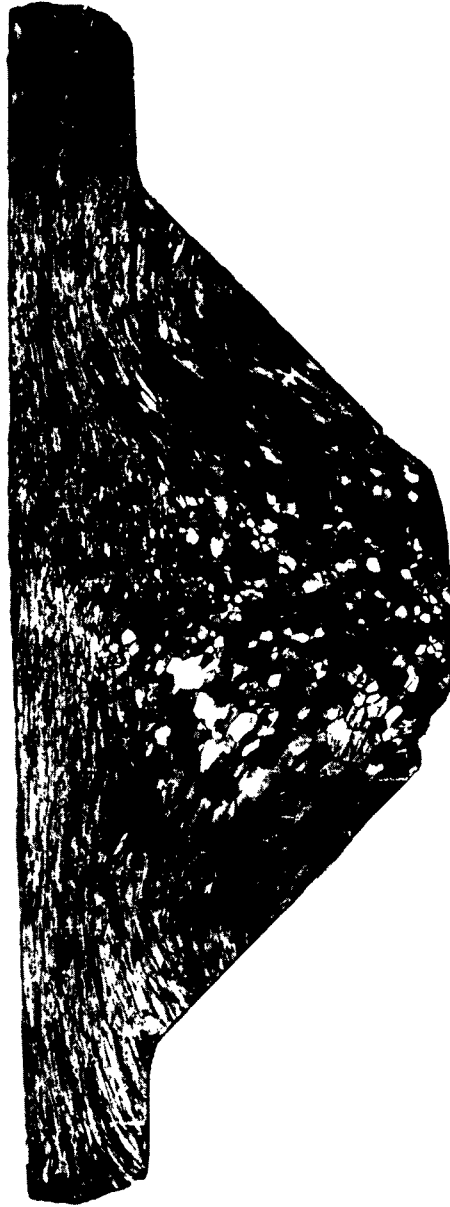
Figure 19 - Macroetched section of blocked tungsten forging made from arc melted billet. Note crack on left side of forging. Cracks are both intra- and trans-granular in nature.

Some of the blocked forgings were sectioned and macroetched. Both intracrystalline and intercrystalline cracks were evident (Figure 19). This was found to be true in both the pressed and sintered and arc melted materials.

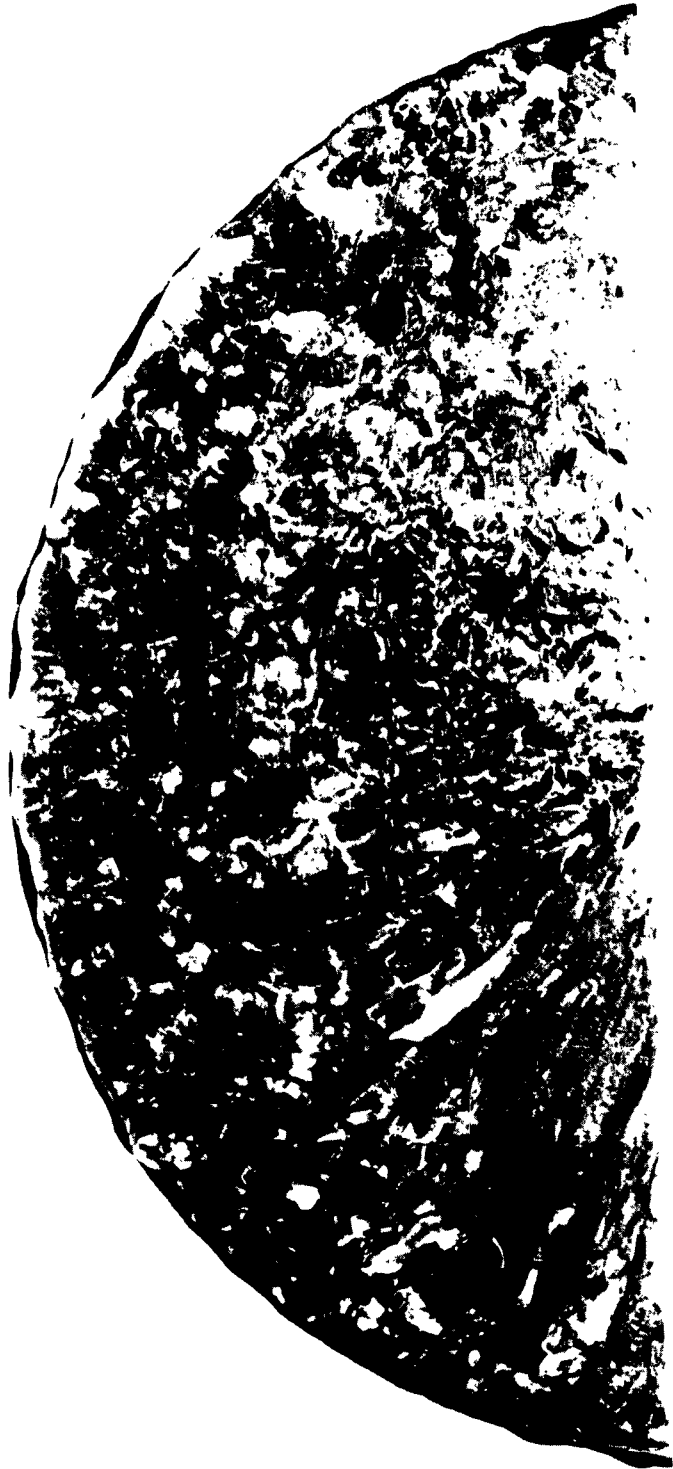
Figure 20 - Top view of forging seen in Figure 19. This forging was made from billet having columnar grain structure.

It is believed that the use of wrought billet stock made little difference in this forging program. The presence of columnar grains (Figure 20) in some of the arc melted billets were also detrimental to the forging characteristics. In the majority of cases, the tungsten forgings had many cracks whereas the TZM forgings had only one or two cracks of limited length.

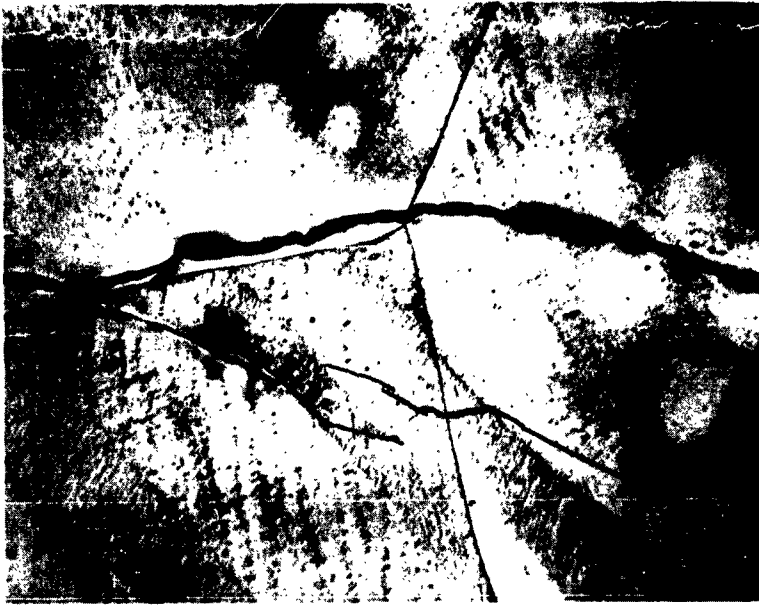
Figure 21 - Example of intragranular type cracking. Material is arc melted TZM molybdenum alloy. 100 X mag. Etched with modified Murakami's Reagent.

Figures 21 and 22 illustrate the intragranular type cracking noted in many of the failures. The material is forged arc melted TZM molybdenum alloy. It should be noted that the grain boundaries were very fine and did not present any obstacle to cracking. The banding that is visible was not observed in all forgings, nor was it in any of the as-received billets that were sectioned. Figure 23 is a view of the banded areas at 1000 X. In any given crystal, there are banded areas as well as non-banded areas.
